Failure Analysis of a Cracked UH-1 Tailboom Former, P/N 205-030-807-97

ARL-TR-3828

June 2006

**Scott Grendahl
U.S. Army Research Laboratory
Weapons and Materials Research Directorate
Aberdeen Proving Ground, MD 21005**

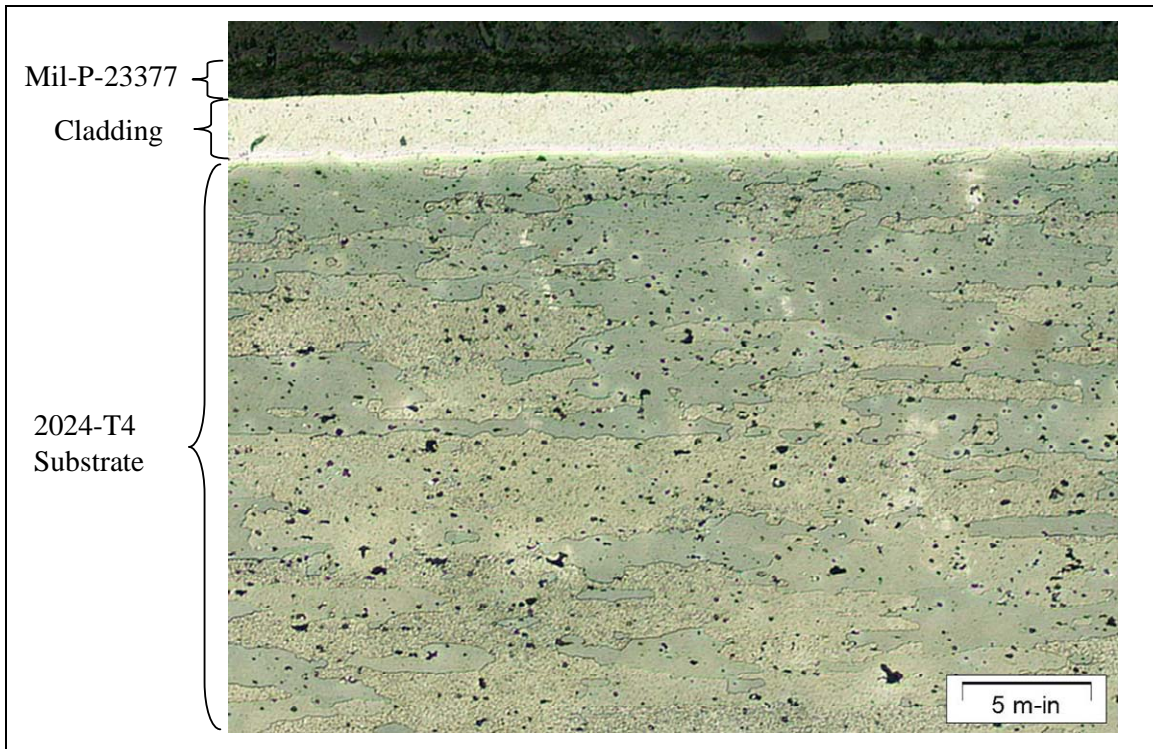
Longitudinal and transverse (to the sheet rolling direction) cross sections were metallographically prepared. The sections were ground and polished through 0.025- μm noncolloidal silica. Subsequently, the specimen was etched with Keller's reagent. The microstructure of the tailboom former material was found to be consistent with clad 2024-T4 aluminum alloy. The cladding can be observed in the longitudinal and transverse direction in figures 20 and 21. The precipitates were determined to be CuMgAl_2 , $\text{Cu}_2\text{MnAl}_{20}$, and Cu_2FeAl_7 . The smaller precipitates formed during the annealing process, while the larger precipitates were undissolved from the solutionizing treatment. No abnormalities were observed. Representative photos of both the longitudinal and transverse cross sections are observable in figures 22 and 23, respectively.

Figure 20. Longitudinal cross section showing the cladding of the 2024-T4 alloy.

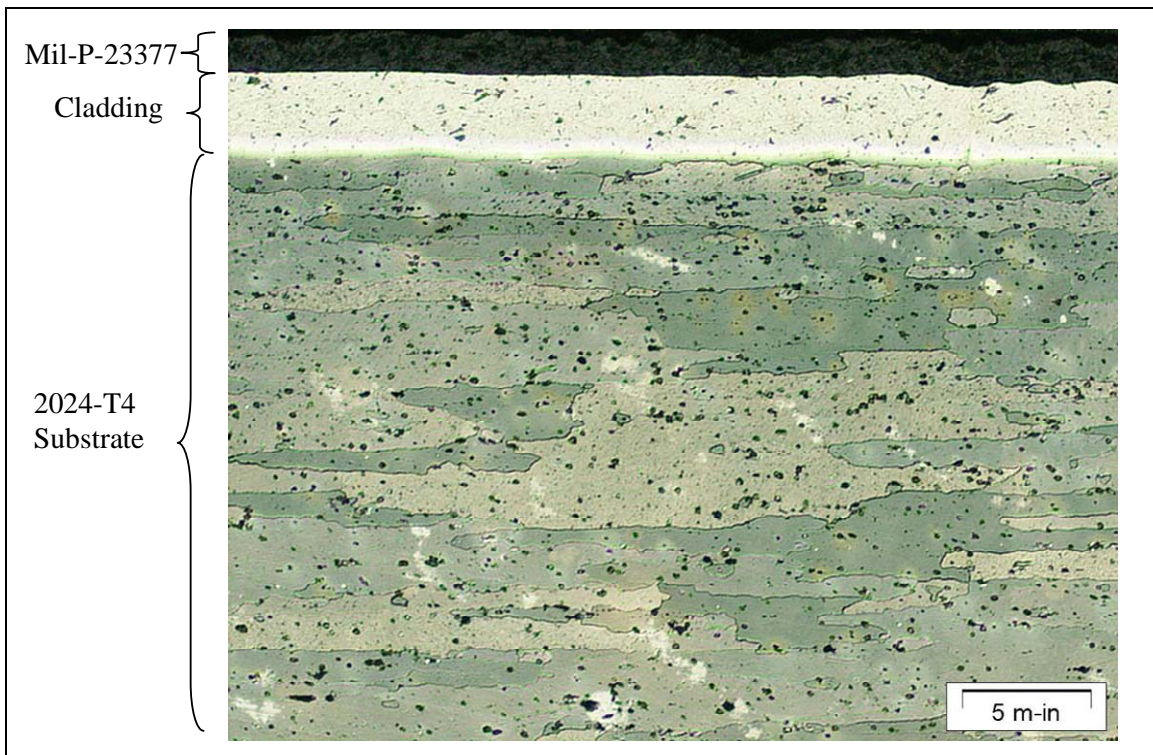
Figure 21. Transverse cross section showing the cladding of the 2024-T4 alloy.
